BESS manufacturing defect overview

PV ModuleTech EU 2025

INTERTEK CEA HAS CONDUCTED QUALITY AUDITS ON OVER 65 GWH OF LITHIUM-ION BATTERY ENERGY STORAGE PROJECTS SINCE 2018

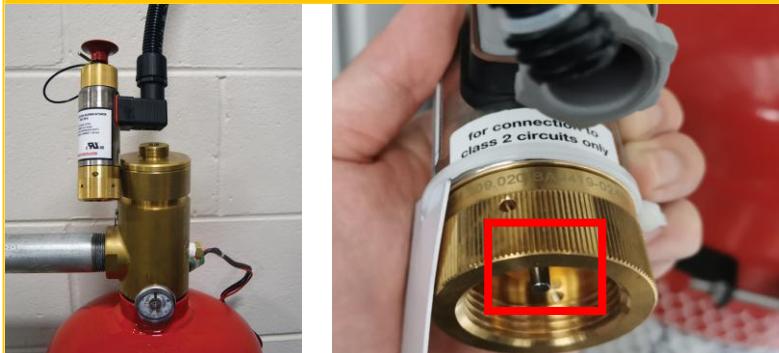
Non-responding release actuator for the fire extinguishing agent

Faulty diode within the actuator.

A malfunctioning **actuator** will not respond to the command of releasing a fire extinguishing agent, potentially allowing the fire to further propagate.

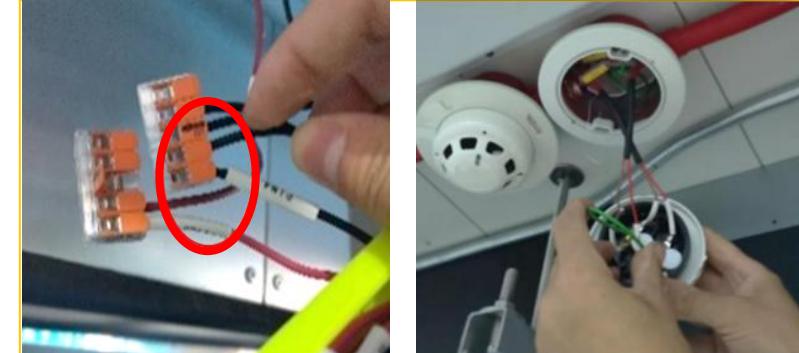
Non-responding smoke & temperature sensors

The **smoke sensor** was incorrectly wired, and a temperature sensor was reversely connected to power source.

An incorrectly **wired** smoke sensor cannot detect the presence of smoke. A reversely connected temperature sensor can have a false reading. Malfunctioning sensors risks fire and explosion or inadvertent activation of fire suppression system.
