# Recent Findings on Glass-Breakage

PV ModuleTech Europe – Malaga, Spain

Steven Xuereb, Executive Director

2 December 2025

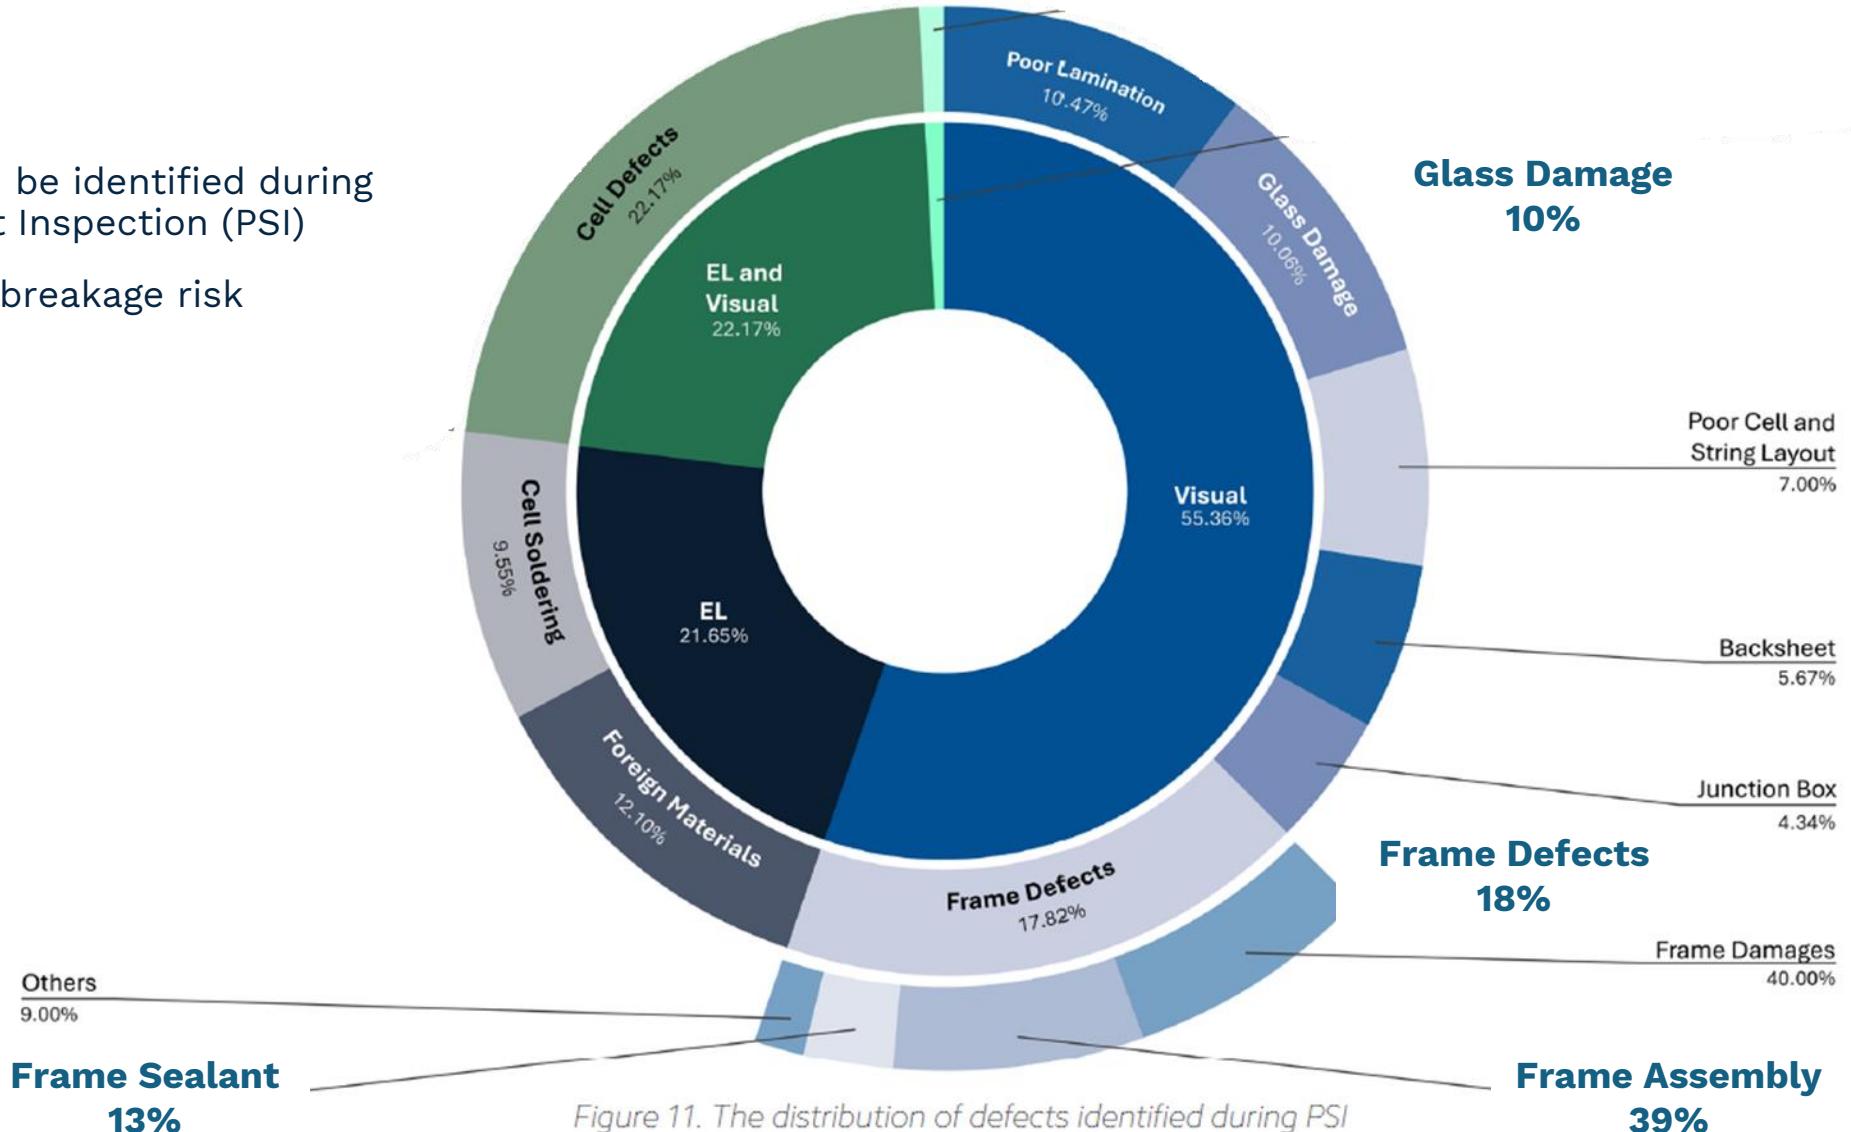
Figure 11. The distribution of defects identified during PSI

Manufacturing defects can be identified during independent Pre-shipment Inspection (PSI)

- Directly impacting glass breakage risk
  - Glass damage
  - Frame assembly
  - Sealant

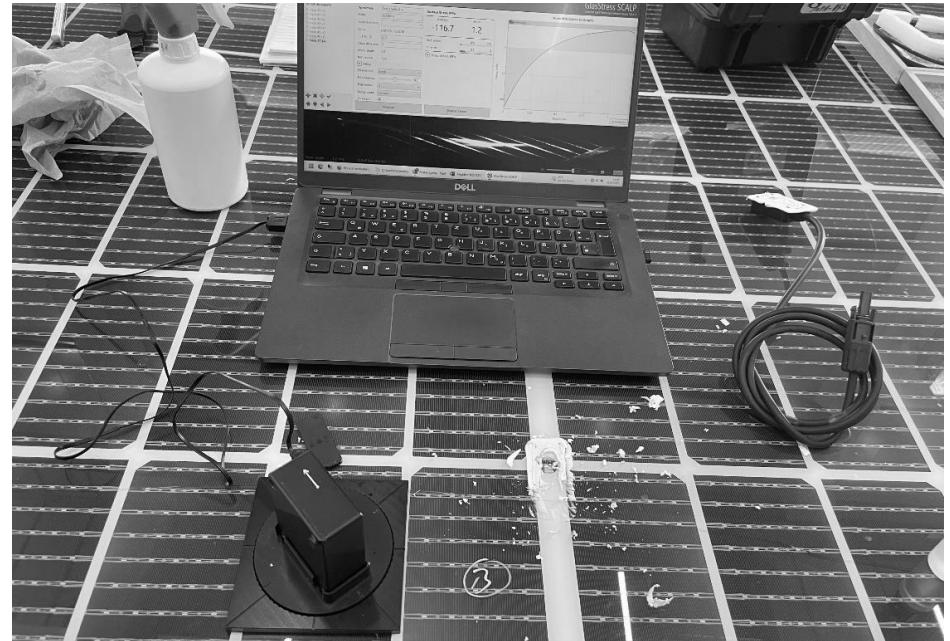
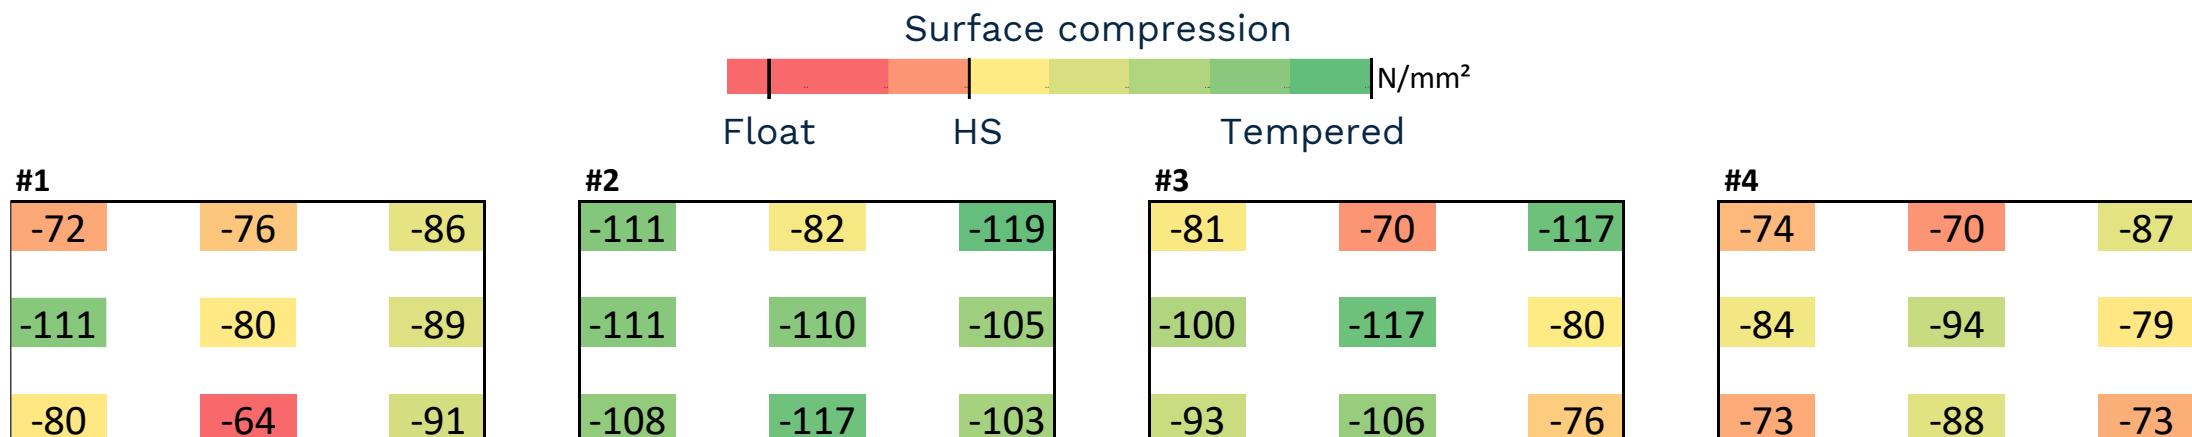
## Inhomogeneity of Surface Compression

- Surface compression on 2 mm rear side glass:  
-64 to -117 N/mm<sup>2</sup> determined over four modules
- SCALP, ASTM C1279-13 (2019)  
*Standard Test Method for Non-Destructive Photoelastic Measurement [...] in Glass*

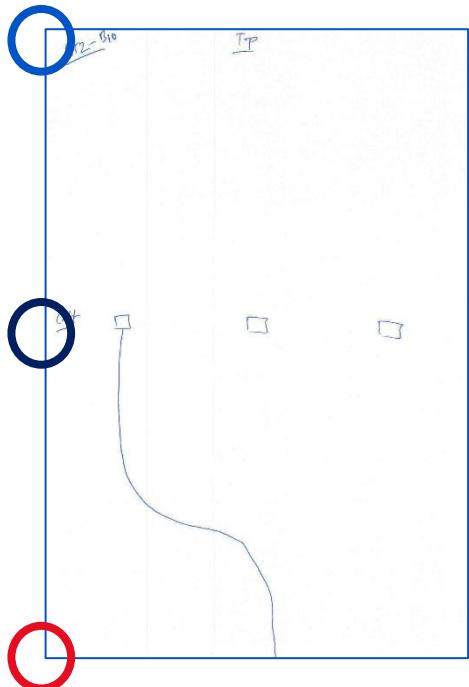
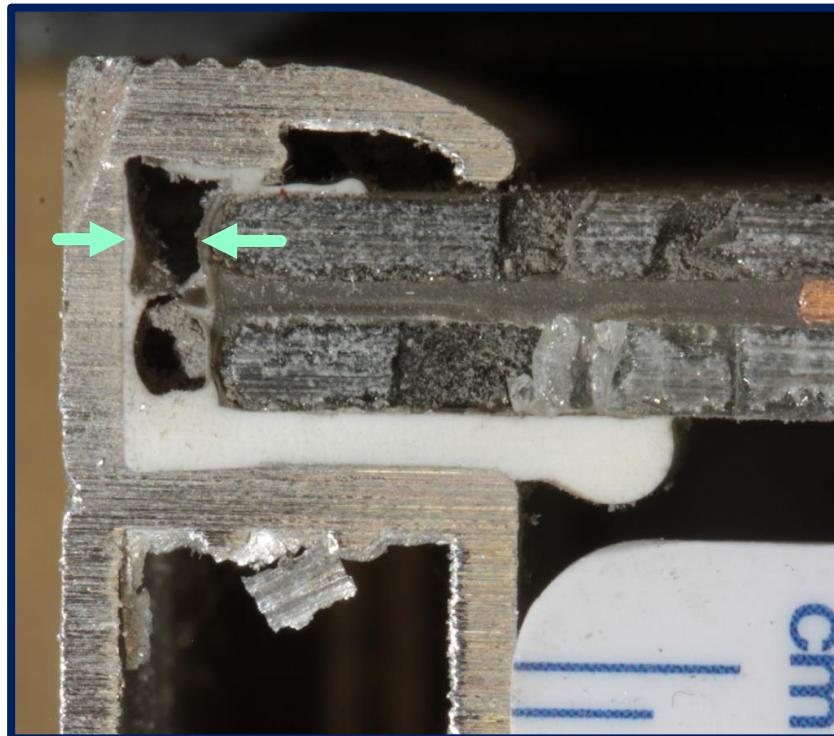
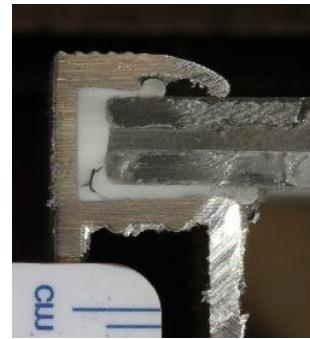
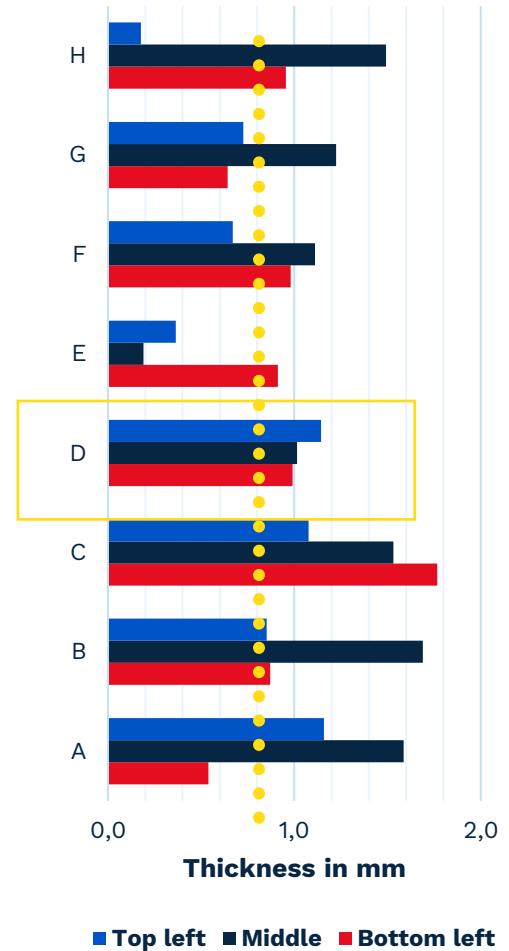
## Cross-section-cut analysis

- Glass thickness measurement
- Sealant quality
- Even distribution of sealant

Silicone (or gap)  
thickness  
@ long side

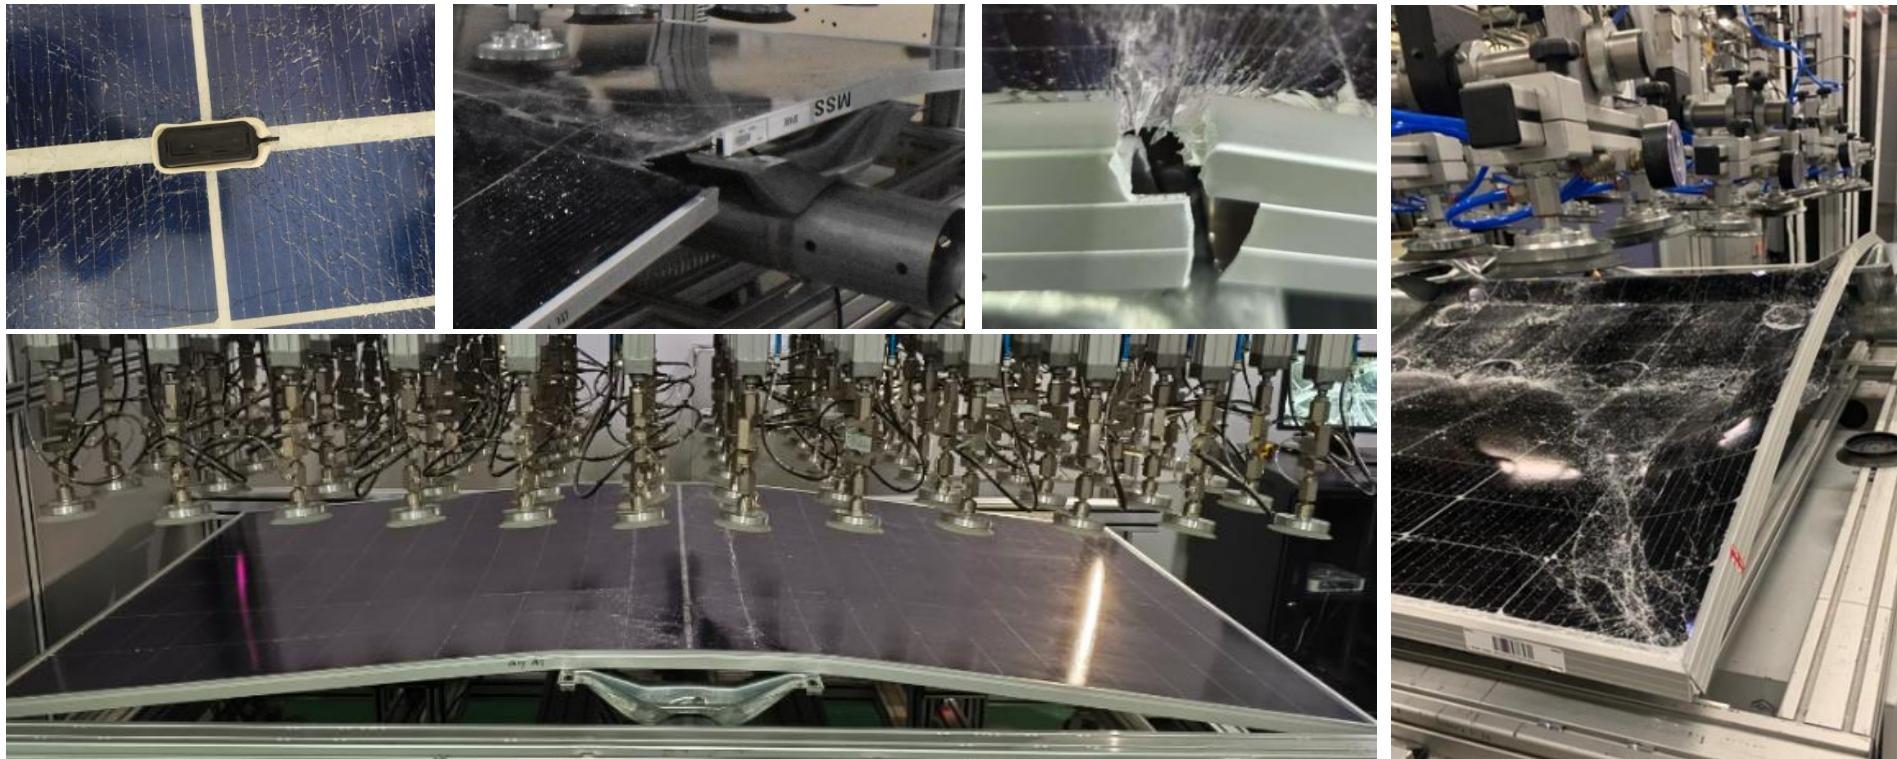
### Static and dynamic mechanical load testing

- 2025 PV Module Reliability Scorecard ([www.scorecard.pvel.com](http://www.scorecard.pvel.com)) results showed:
  - 20% of BOMs undergoing the PQP's Mechanical Stress Sequence (MSS) experience broken glass or frames
  - 40% of manufacturers experienced at least one failure during MSS testing

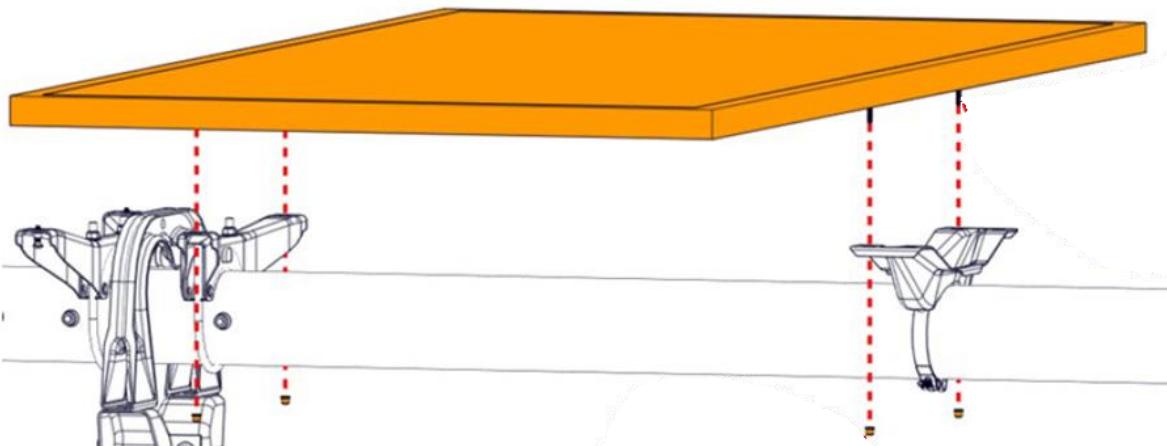
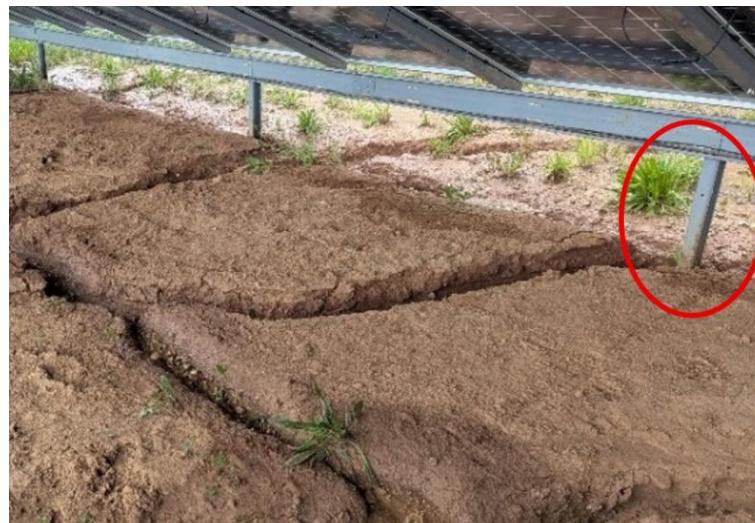
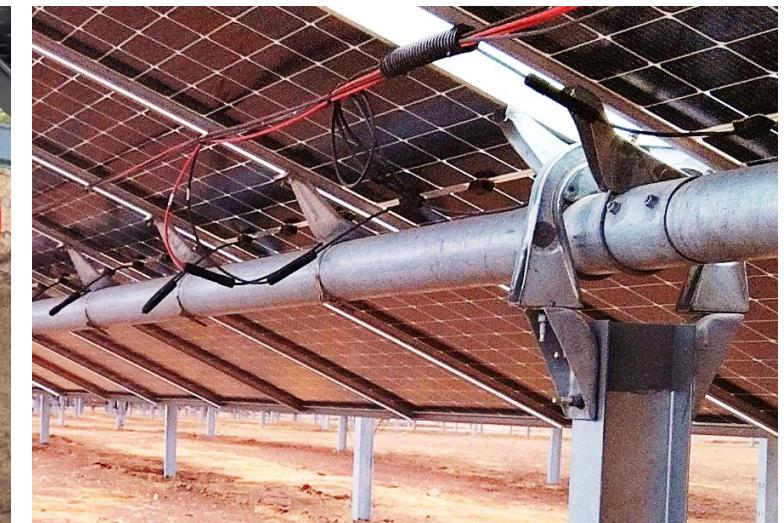
### Incompatibility Between Module and/ or Mounting Support

- On-site inspection:
  - Incorrect module mounting holes used
  - Torque level too high or too low
  - Unstable foundations

- Inspection of foundation installation
- Verifying of module mounting position and torques
- Improving O&M activities (e.g. grass cutting with cover, limiting vehicle speeds)

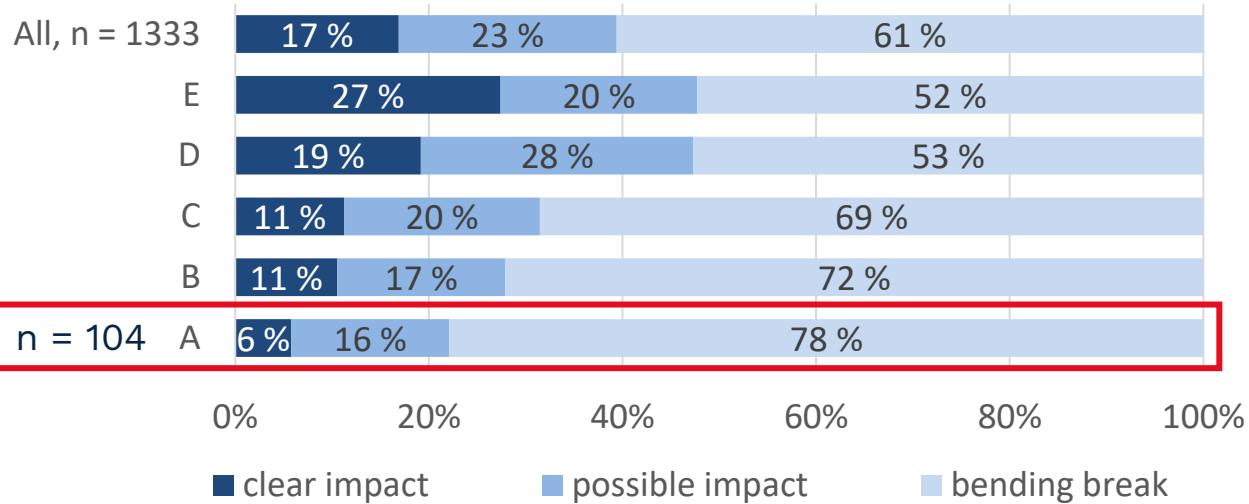
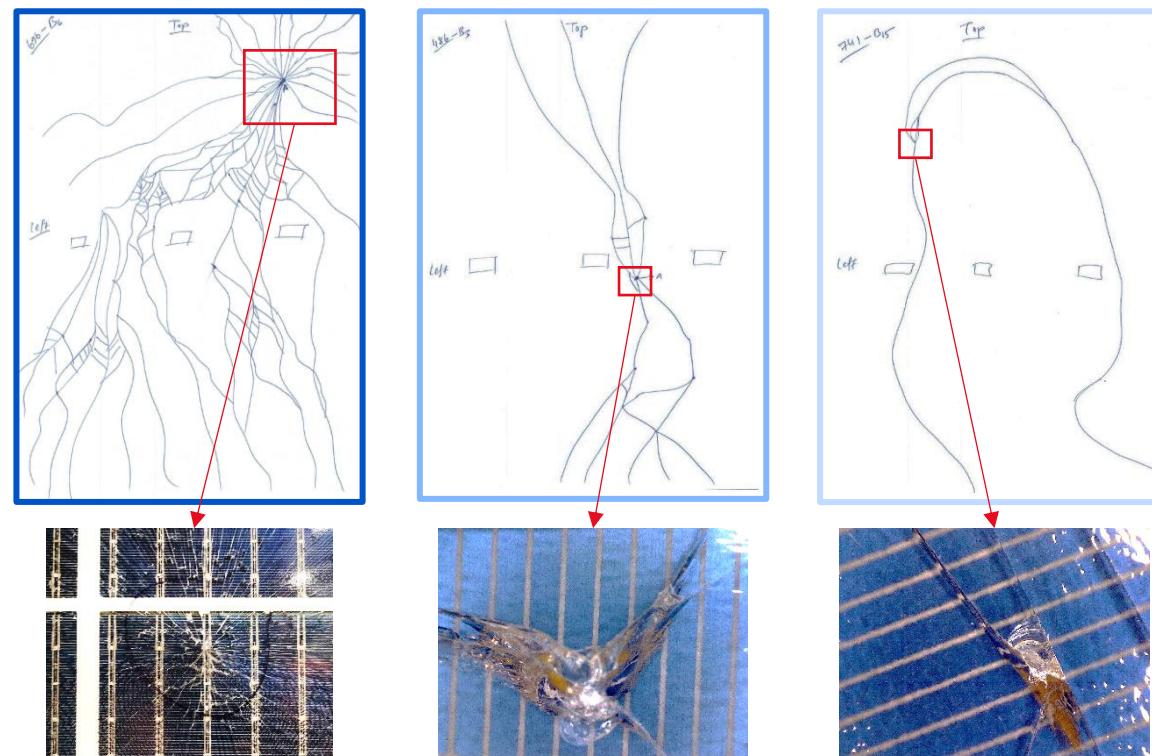
### Impact from flying objects

- 6 to 27% of the broken modules show **clear signs of impact**, but many others not obvious
- Some evidence of thrown stones and mud, one case (E) clearly from cleaning device
- Microscopic validation of impact is important
