# Recent Findings on Glass-Breakage

PV ModuleTech Europe – Malaga, Spain

Steven Xuereb, Executive Director

2 December 2025

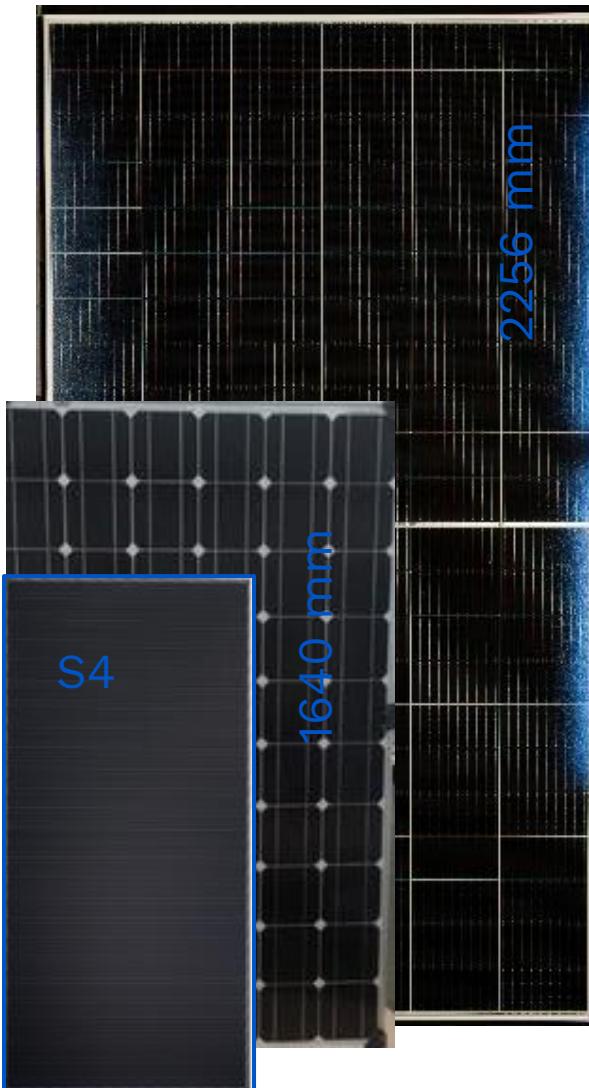
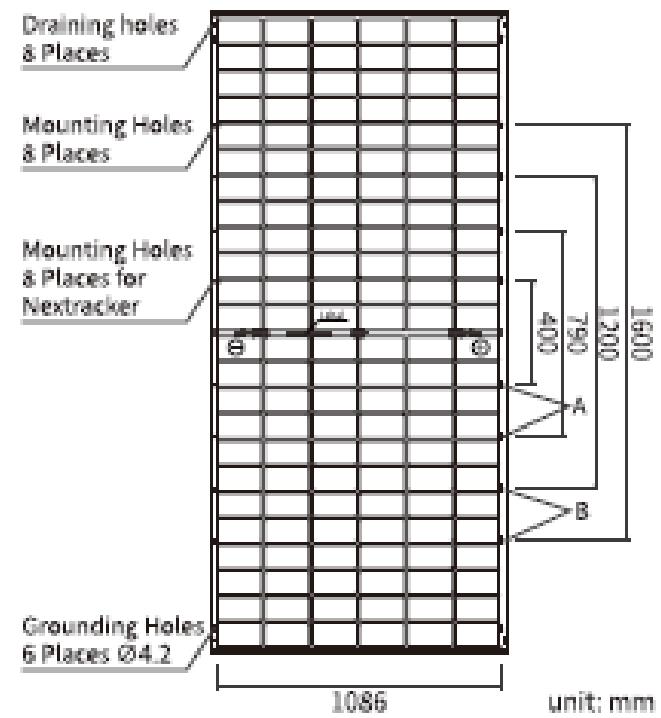
## 1. Module Design

- More than 80% of all modules manufactured now are glass/glass
- Module size has more than doubled in last 10 years
- Three junction box holes at module centre, instead of one at the top
- Mounting holes still at same distance leading to higher bending stresses
- Frame width and thickness shrinking

- Less rigid
- Load bearing
- Higher stresses

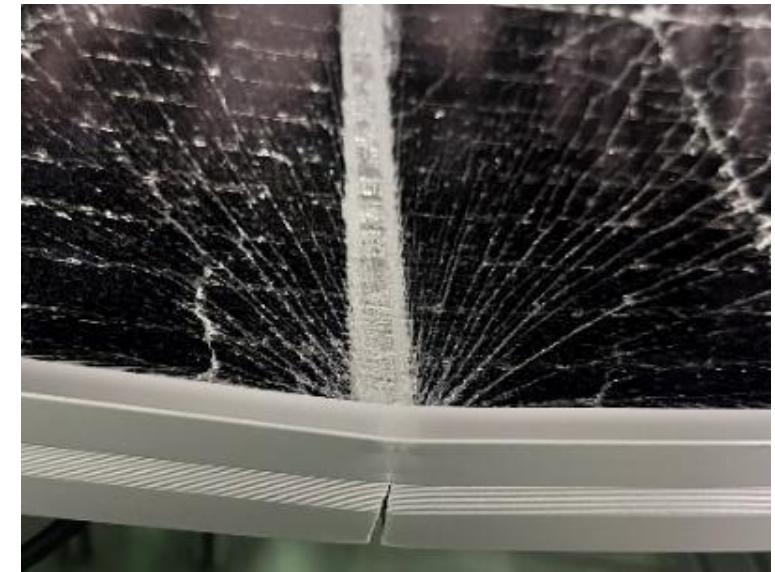
### 2. Glass Quality

- Glass/backsheet modules used 3.2mm fully tempered glass
- High flexural strength and a larger range of temperature resistance
- Glass/glass modules currently on the market are using 2mm heat strengthened glass
- 50% lower bending strength and temperature resistance

➤ Weaker
➤ More sensitive to impact
➤ More sensitive to operational loads

Material	Flexural strength	Temperature change resistance
Float glass	45 N/mm <sup>2</sup>	40 K
Heat strengthened glass	70 N/mm <sup>2</sup>	100 K
Tempered glass	120 N/mm <sup>2</sup>	200 K
